Base: U.S. Geological Survey 7.5-minute Seaside quadrangle, photorevised 1968

QUATERNARY DEFORMATION LOCALITIES

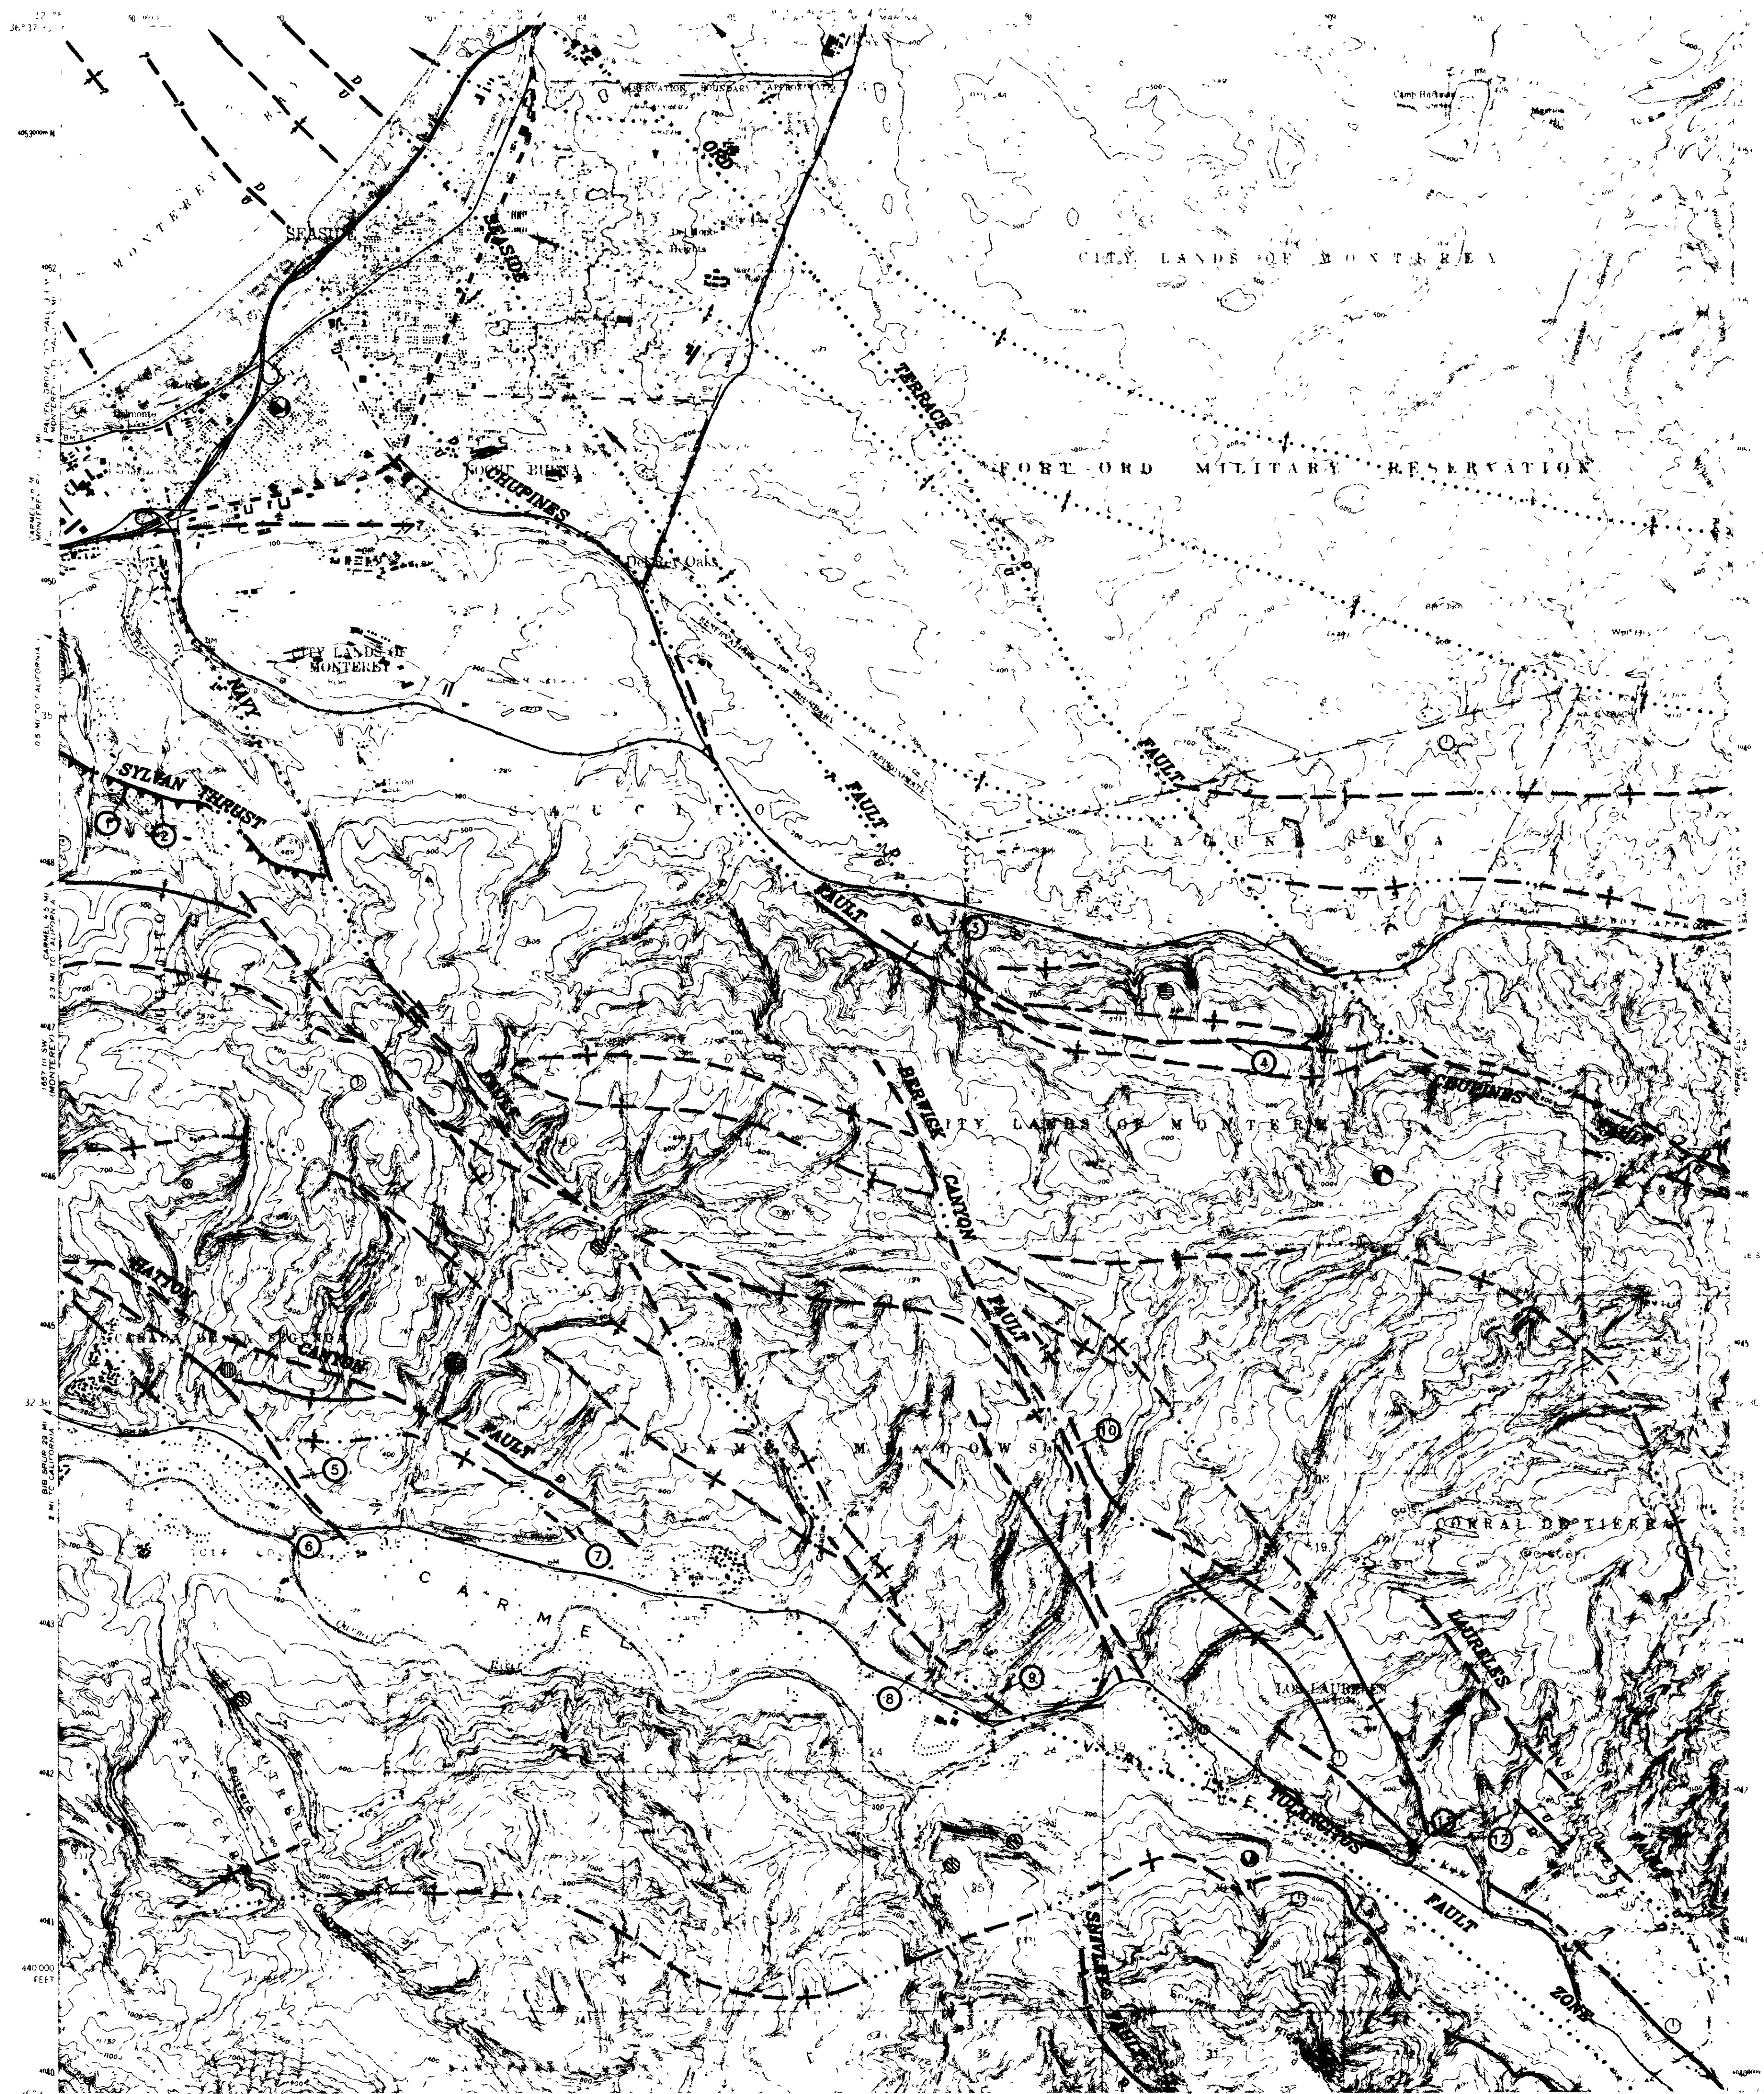
High-angle fault — solid where fault is well-defined, dashed where approximately located or poorly defined, dotted where concealed, queried where questionably located. Relative vertical movement shown by U and D (U=upthrown side, D=downthrown side). Arrows indicate relative movement.

Thrust fault — solid where fault is well-defined, dashed where approximately located or poorly defined, dotted where concealed, queried where questionably located. Saw teeth on upper plate.

Fold axis — solid where well-defined, dashed where approximately located or poorly-defined, dotted where concealed. Arrow on axial trace indicates direction of plunge.

Quaternary deformation locality

- Marine terrace deposits with approximately 2 m of cumulative offset along a narrow fault zone (down to the east) that strikes approximately N. 50° W., dips 70° NE. (Dupré, 1990b)

- Thrust faulted marine terrace deposits with estimated 15–20 m of throw (up to the south) along eastern extension of Sylvan thrust; terrace deposits tilted approximately N. 65° W., dip 28° NE. (Dupré, 1990b)

- Near-vertical fault splay of Chupines fault zone exposed in trench; stratigraphic relationships and soil profiles suggest Holocene displacement (Vaughan and others, 1991)
